REPORT NO: NAWCADPAX/TR-2000/59

BREAKDOWN OF PRESERVATIVE FLUID MIL-PRF-46170 IN AIRCRAFT HYDRAULIC SYSTEMS

29 March 2001

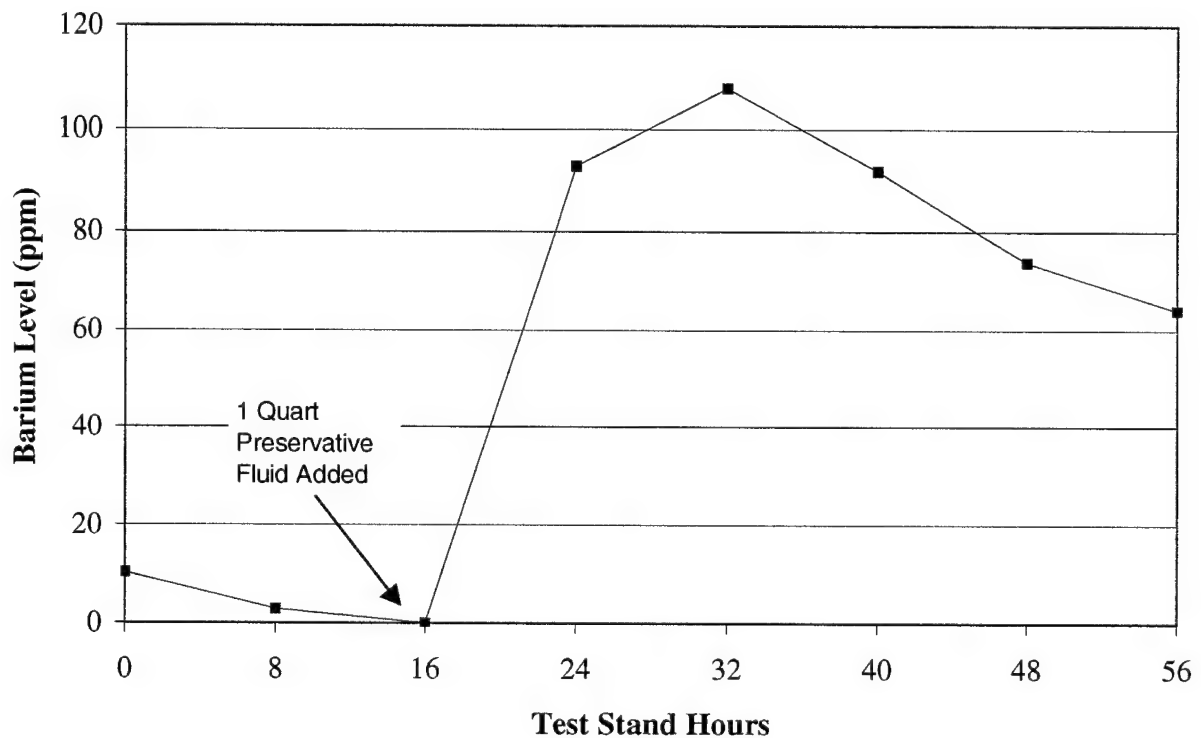
Figure 2: Fluid Barium Level Versus Time

Fluid temperature was maintained at 215°F and the first 2 days of testing were performed without preservative fluid to ensure a clean system. Filter loading for the first 2 days was minimal. Note that fluid barium level was reduced from 13 ppm to 0 ppm in the first 16 hr of testing as residual preservative was removed from system fluid.

The beginning of the third day, 1 qt of preservative fluid was added after 16 hr of operation (shown in figure 2). The rate of filter loading significantly increased after adding the preservative fluid. The level of residual preservative in fluid was steadily reduced as organic material was collecting on the filter.

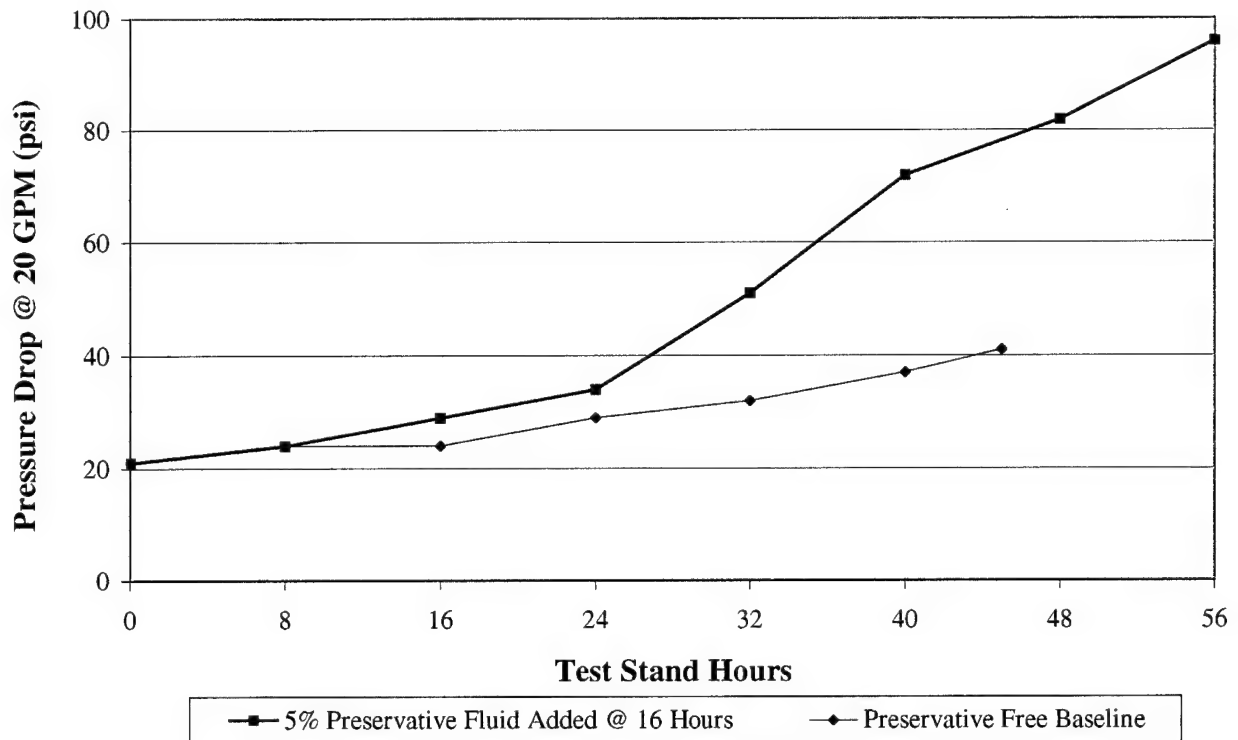
Figure 3: Filter Element Pressure Drop Versus Time

Additionally, baseline testing was performed with 100% hydraulic fluid to quantify the effects of preservative on filter clogging. Baseline testing with low levels of preservative showed minimal filter loading for the first 45 hr of testing (figure 3).

System baseline testing had progressed to 45 hr with minimal filter loading when an abrupt increase in pressure was observed. Inspection of the system identified a rupture in the heat exchanger that was adding large amounts of water to system fluid.
